Assessment report: State of the wooden construction, fresh water marina, Akkrum

Report code: 20.0382

Date: December 11th, 2020

Entries: Monitoring, timber species, landing stages, sheet pile, gang planks / boards, poles (hewn, sawn, round), purlins, stop logs poles, identification, decay.

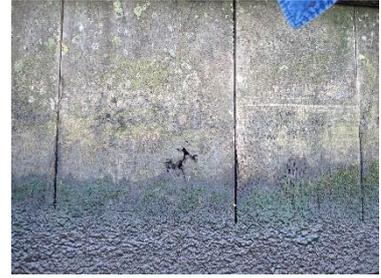
Sheet piles 1a, okan, start from the 25th sheet pile along the main river pathway (after the corner with the combination sheet piles, no. 3), thickness 40 mm, width 255 mm, 26th sheet width 155 mm, following sheets with variable width. Interlocked grain, fine wood structure, compared to all other sheet piles it is remarkable that there was almost no algae, mosses or plant growth; good condition (visually no decay and density profiles show weak decay only in outermost parts on top landside 15 mm, lower at waterside 10 mm). 27th sheet is sampled (M4) and density profiles were made.

Remarkable little attached growth of algae and mosses

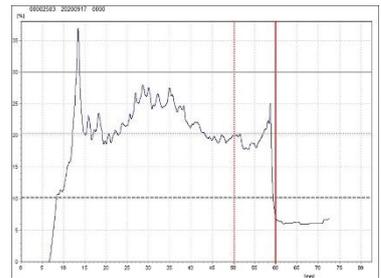
2505: no significant decay only weak decay landside 15 mm

2504: thickness 40 mm; no significant decay only weak decay waterside 10 mm

2503: no significant decay only weak decay waterside 10 mm

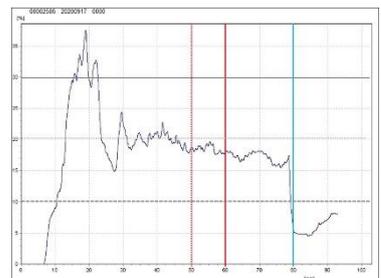
Sheet piles 1b, azobé, starts after sheet piles 1a and have variable widths of 240, 310, 320 and 340 mm. They have interlocked grain, fine wood structure, condition good (no visible decay, density profiles show only weak decay top 10 mm at landside, middle 10 mm at waterside and water level 5 mm in middle). 27th sheet is sampled (M5) and density profiles were made.

2508: no significant decay only weak decay landside 10 mm

2507 thickness app. 50 mm, no significant decay, only weak decay waterside 10 mm

2506: no significant decay, only weak decay behind a thin hard layer in 5 mm

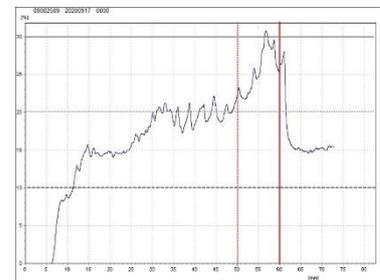
Condition relative good (visible/ awl at top pile landside 5 mm decay, density profiles show only weak decay in the middle parts, most prominent in the upper 250 mm); the same sheet pile is sampled (M6) as from which the density profiles were made.

2509: no significant decay, only moderate decay waterside 5 mm and weak decay middle 20 mm
WL just above water level (water side)

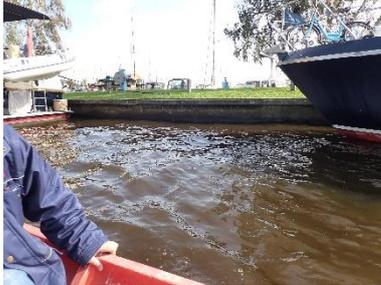
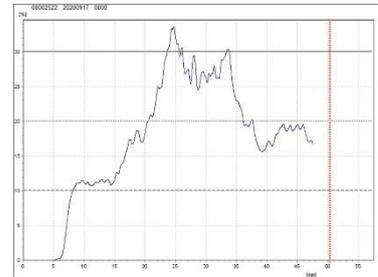
Sheets piles 1d, tali, next after 1c sheet piles are located between pole 15 and 16. Thickness at least 40 mm. Condition relative good (visual no decay, density profiles moderate decay 10 mm deep waterside from 150 mm downwards, weak decay landside 5-15 mm top to water level, and middle top to 300 mm downwards 15 mm); the same sheet pile is sampled (M7) as from which the density profiles were made.

2527: no significant decay, only weak decay landside 5 mm and middle 15 mm

2521 thickness more than 40 mm; moderate decay waterside 10 mm, weak decay landside 15 mm and middle 15 mm

2522: moderate decay waterside 10 mm, weak decay landside 15 mm rest no significant decay

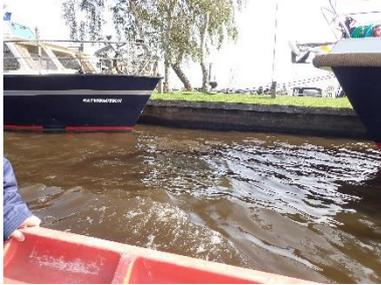
Sheet piles 1e, okan, next few sheets piles after 1d sheet piles are located around pole 13. Thickness 50 mm. Condition relative good (visual, awl at top landside 1-2 mm decay, density profiles show weak decay in the middle and at the top landside 20 mm, and at the water level waterside 15 mm); the same sheet pile is sampled (M8) as from which the density profiles were made.

2532: weak decay landside 20 mm and middle 10 mm, rest no significant decay

2533 thickness app. 50 mm; weak decay waterside 15 mm and middle 20 mm, rest no significant decay

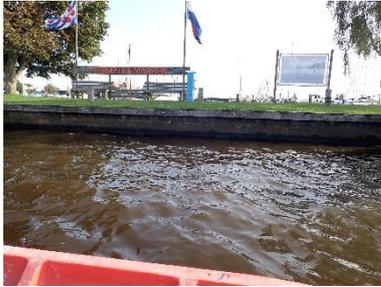
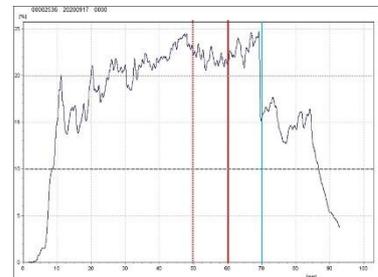
Sheet piles 1f, tali, next few sheets piles after 1e sheet piles are located around pole 9. Thickness 50 mm. Condition is good (density profiles show weak decay at waterside over whole length in 5 mm, and at the top in the middle 5 mm). The same sheet pile is sampled (M9) as from which the density profiles were made.

2534: no significant decay, only weak decay landside 5 mm, middle 5 mm (behind hard peal waterside)
AB upper part (land side, approximately 15 cm from head)

2535 thickness app. 50 mm, no significant decay, only weak decay waterside 5 mm
HV just below purlins (water side, 30 cm from head)

2536: no significant decay, only weak decay behind hard peal waterside 5 mm
WL just above water level (water side)

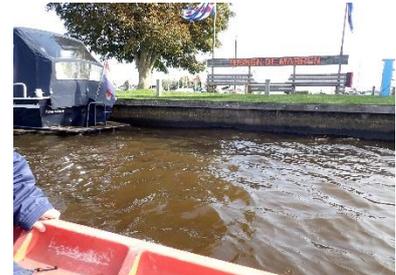
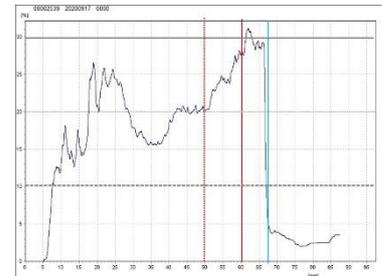
Sheet piles 1g azobé, next few sheets after 1f sheet piles are located around pole 7. Thickness 50 mm. condition questionable (visual / awl top landside white rot 30 mm deep, density profiles show moderate decay in the upper 300 mm at the landside 10-20 mm and in the middle part 15-25 mm, at the water level the decay is less weak); the same sheet pile is sampled (M10) as from which the density profiles were made.

2537: moderate decay landside 10 mm, middle 25 mm, weak decay waterside 15 mm

2538 thickness app. 50 mm, decay moderate landside 20 mm, moderate -severe middle 15 mm, rest (waterside) no significant decay 25 mm

2539: weak decay waterside 10 mm, middle 35 mm, rest (landside 15 mm) no significant decay

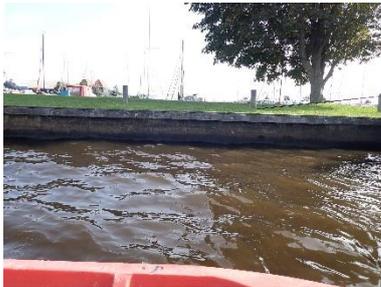
Sheet piles 1h, araracanga, next few sheets after 1g sheet piles are located around pole 5. Thickness 50 mm. Condition good (visual / awl top landside superficial decay, density profiles no significant decay, only weak decay at top both land-and waterside in 5 mm, and at the water level waterside 10 mm and middle 20 mm); the same sheet pile is sampled (M11) as from which the density profiles were made; this is the last pile of this species.

2540: no significant decay, besides weak decay landside behind hard peal 5 mm, waterside 5 mm.

2542 thickness app. 50 mm, no significant decay

2544: weak decay waterside 10 mm, middle 20 mm, rest no significant decay

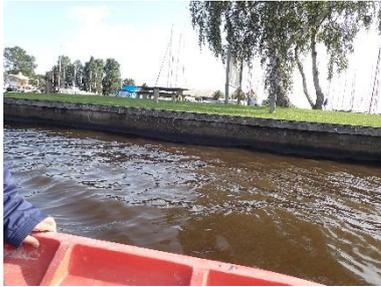
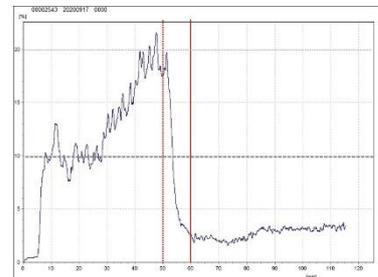
Thickness 50 mm. Condition bad (visual / awl top landside deeply degraded, density profiles show moderate to severe decay in large parts of the pile); the same sheet pile is sampled (M12) as from which the density profiles were made, is the first pile of this species.

2541: decay moderate to severe over whole thickness.

2543 thickness app. 50 mm, decay moderate landside 20 mm, middle 20 mm, rest weak of no significant decay just below purlins (water side, 30 cm from head)

2545: moderate to severe decay waterside, moderate decay middle 20 mm, weak decay landside just above water level (water side)

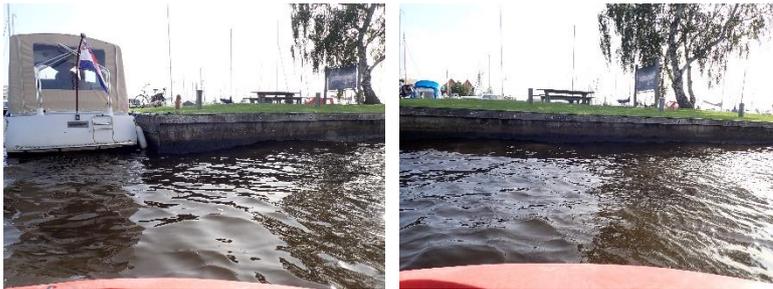
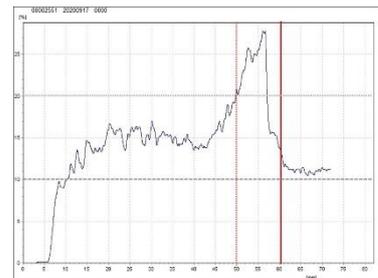
Sheet pile of okan

Sheet piles 1j, okan, next few sheets after 1i sheet piles are located near pole 1. Thickness 50 mm.

Condition bad (visual / awl top landside 50 mm decay, waterside no significant decay, density profiles show moderate decay in large parts of the pile); the same sheet pile is sampled (M13) as from which the density profiles were made.

The sheet pile left of that last one is another species and its condition better (density profiles show moderate decay throughout the whole thickness in the middle part, top only weak decay landside 10 mm and at water level moderate decay landside 10 mm and weak decay waterside 15 mm).

2546: decay moderate to severe over whole thickness.

2548: decay moderate to severe over whole thickness

2551 thickness app. 50 mm, decay moderate 45 mm, only weak -no decay landside 5 mm

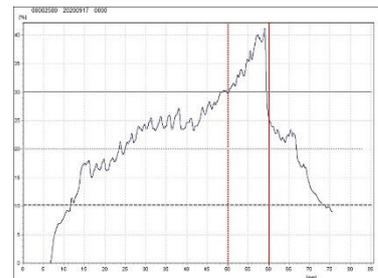
Sheet piles 2, angelim vermelho, the first 24 sheets piles along the main river pathway after the corner with the combination sheet piles 3. It is assumed that the lower parts of the sheet piles is Austrian larch, thickness 45 mm, width approximately 180 mm, rabbet 20 x 20 mm. The condition of the piles is good (no visible or with density profiles detectable decay), third sheet is sampled (M3) and density profiles were made.

2502: no significant decay both water and landside

2501: thickness is app 45 mm, no significant decay both water and landside

2500: no significant decay only 5 mm weak decay waterside

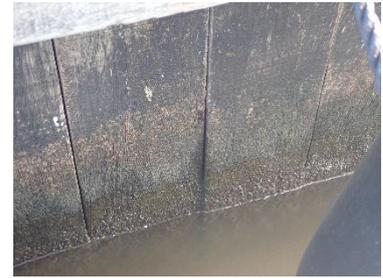
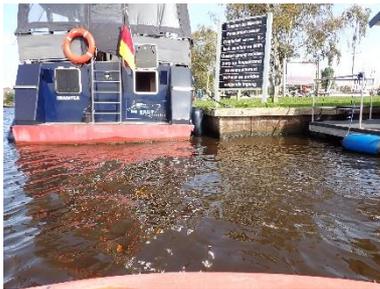
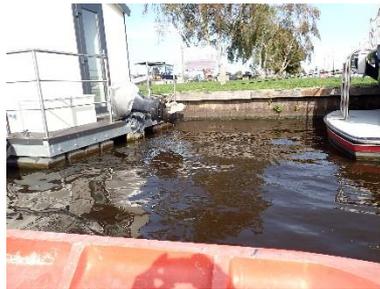
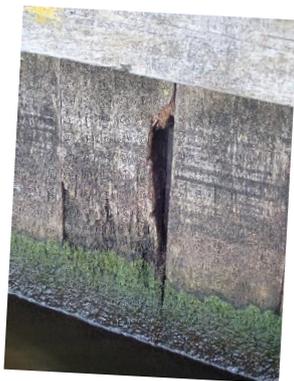
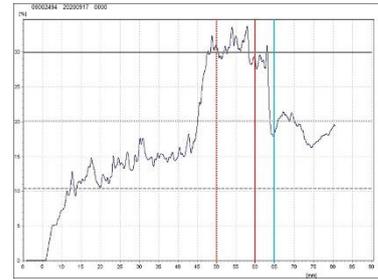
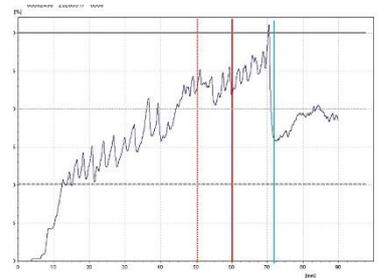
Sheet pile 3, combination sheet pile (Van Swaay), situated over the full short end of the island. The upper part is angelim vermelho, thickness 45 mm, width approximately 180 mm, rabbet depth 20 mm, 22 mm wide and the lower part is probably a softwood. Most upper parts are sound, no decay, a few upper parts show some bugling and occasionally some plant growth through the nails.. The condition of the eighth sheet from the corner with the frontside of the island, was questionable (visually degraded, density profiles show weak to moderate decay on waterside at middle) (M1, lost its smell), adjacent sheet was good (visually no decay, density profiles show weak decay in top 15 mm on landside, 10 mm middle), (M2). Both samples confirm the wood species.

2498: landside no significant decay, weak decay middle 25 mm, moderate decay waterside 10 mm

2495: no reliable thickness estimation here because of skewed measurement; landside no significant decay, weak decay middle 10 mm, moderate decay waterside 25 mm

2494: landside no significant decay, weak decay in middle and waterside 35 mm

Degraded sheet (M1)

Sheet pile with no visual degradation (M2)

2499: landside weak decay in 15 mm, 10 mm in middle, rest no significant decay

2497: no reliable thickness estimation here because of skewed measurement; weak decay in middle 10 mm, rest no significant decay

2496: no significant decay for both water and landside

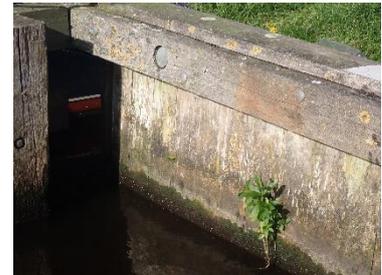
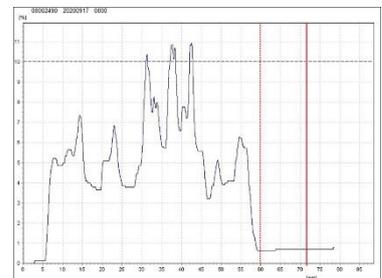
Approximately 39 combination sheet piles with Accoya, thickness 53 mm, width 132 mm, moisture content (at density 0,65 g/cm³) both land and water side 20-35%, no detectible decay, finger joints to the supposed lower spruce part were not detected (between cross surface Accoya and decking at least 5 mm space, some plant grow between the beams).

2493: no significant decay both water and landside

2491: no reliable thickness estimation here because of skewed measurement; no significant decay both water and landside

2490: no significant decay both water and landside

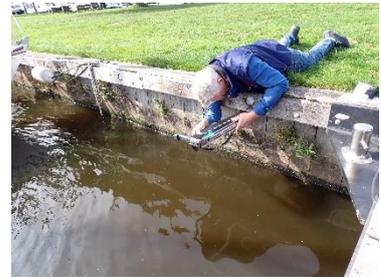
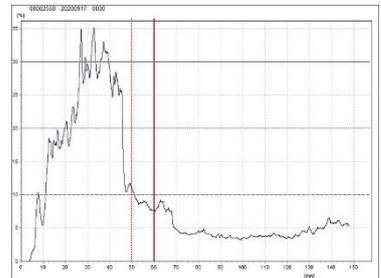
Sheet piles 9, reused azobé sheet piles. Thickness 50 mm. Condition good (visual / awl top landside superficial decay, density profiles no significant decay, only weak decay at top both land-and waterside in 5 mm, and on the water level waterside 10 mm and middle 20 mm); the same sheet pile is sampled (M16) as from which the density profiles were made, is the last pile of this species. Cover plank severely degraded with many ants.

2556: no significant decay, besides weak decay landside behind hard peal 5 mm, waterside 5 mm.

2557 thickness app. 50 mm, no significant decay

2558: weak decay waterside 10 mm, middle 20 mm, rest no significant decay

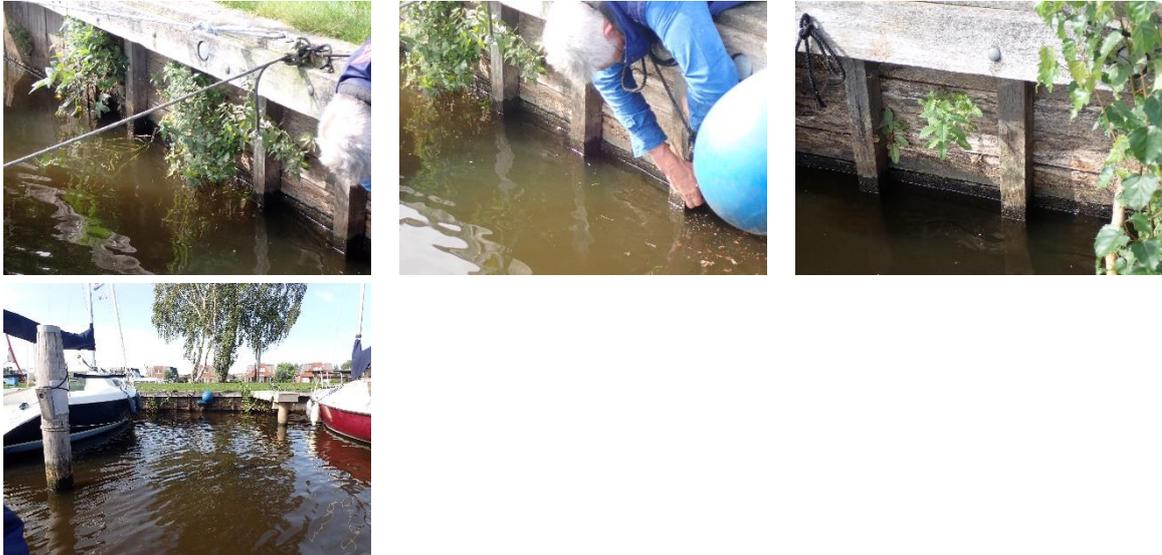
Location 10, robinia bulkhead and kopie (cupiuba) poles. Condition poles good (visual / awl above water part is hard), bulkhead bad (severe decay), wood sample M15. Extensive plant growth was seen.

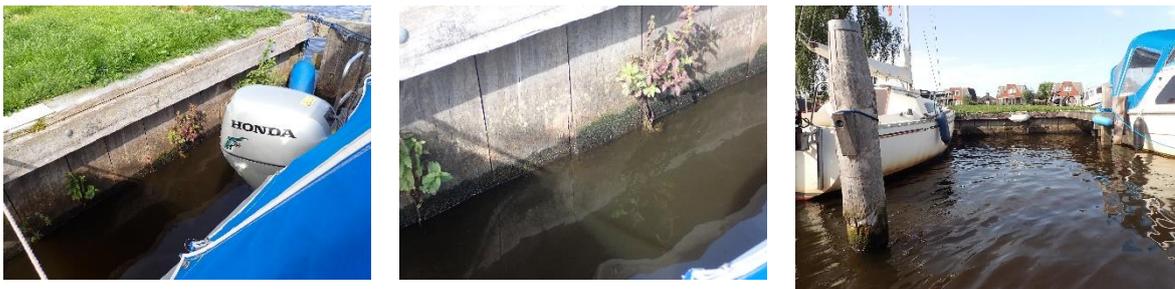
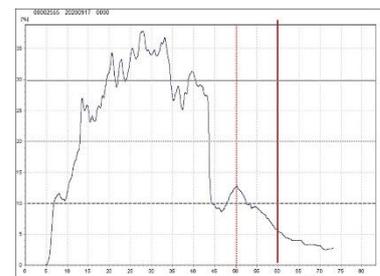
Sheet piles 11, azobé, sheets are a supposed continuation of the reused azobé under 9 until the corner of the island. Thickness 40 mm. Some plants grow through the seams, wall is coherent. Condition questionable (visual / awl waterside hard, landside not reachable, density profiles show moderate decay in upper part and in lower parts weak decay land- and waterside 5-10 mm; the same sheet pile is sampled (M14) as from which the density profiles were made, is the last pile of this species.

2553: weak decay over the full thickness, hard peal waterside.

2554 thickness app. 40 mm, no significant decay, only weak decay land- and waterside 5 mm, HV just below purlins (water side, 30 cm from head)

2555: no significant decay, only weak decay land- and waterside 10 mm
WL just above water level (water side)

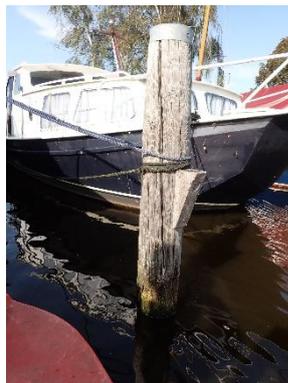
Third pole west from the entrance landing stage, larch

Round softwood pole, above the water line, one large crack and some small cracks, no significant fungal decay. On the water air line 10-20 mm decay, below the water surface sound. Wood sample (MP1) was taken.

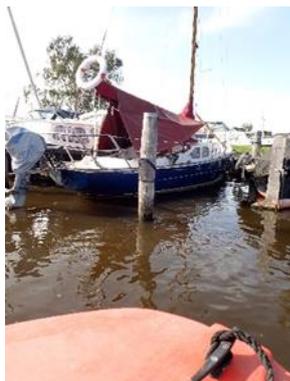
Fifth pole (MP2)

Fifth pole west from the entrance landing stage, cloeziana

Round hardwood pole, no significant decay on and above the water line. Diameter poles approximately 22 cm. The density profile taken approximately 20 cm above the water line, shows a degraded outer most sheet of 20-30 mm. Wood sample (MP2) was taken.

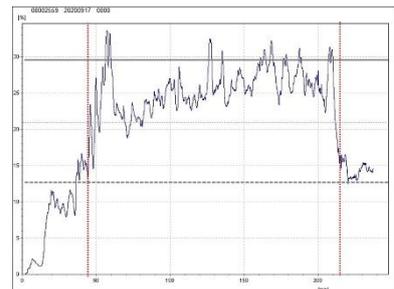
11th and 10th pole left from the entrance landing stage

Adjacent poles (7th, 8th, 9th, 10th, 11th and 12th from the entrance landing stage), cloesiana. Similar in species and decay as the fifth pole. From pole 7th a wood sample (MP3) was taken

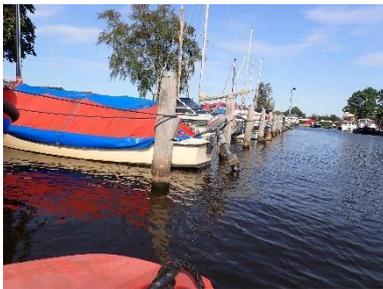
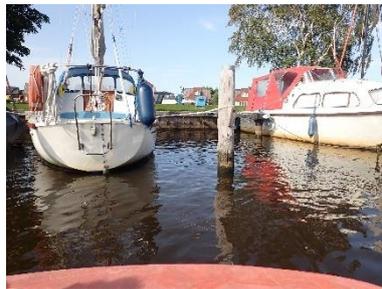
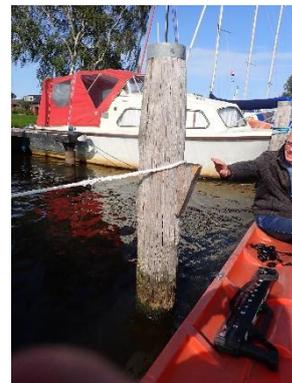
Round hardwood poles, diameter 24 cm in the part above the water level with many cracks perpendicular to the fibre angle, many small holes (< 1 mm in diameter longitudinal or cross cut) of pinhole borers, further no significant decay, wood sample (MP4).

Left picture: poles at the right of but close to the entrance landing stage, middle and right pictures: 3rd pole from which sample MP4 was taken

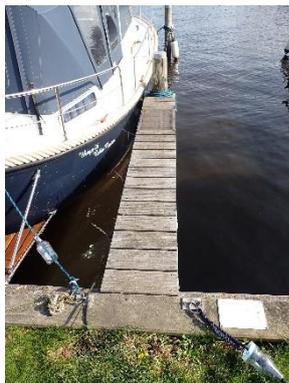
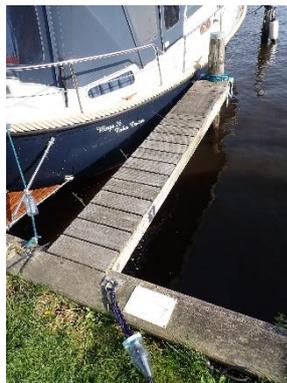
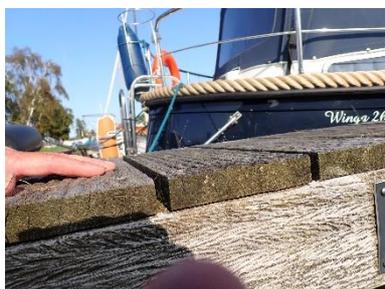
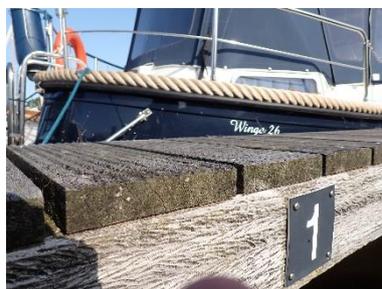
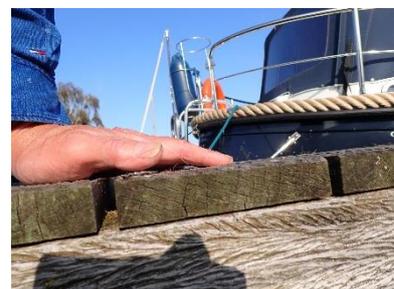
Landing stage 1 padoek in both gang boards and horizontal construction.
Condition good, sample taken from gangboard (S4), species confirmed

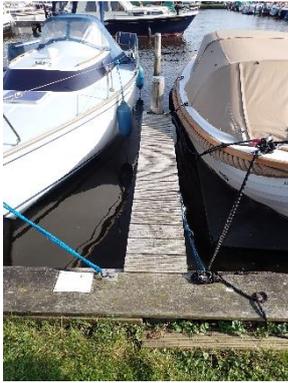
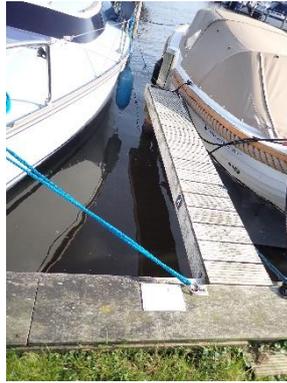
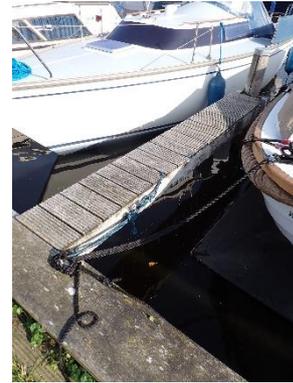
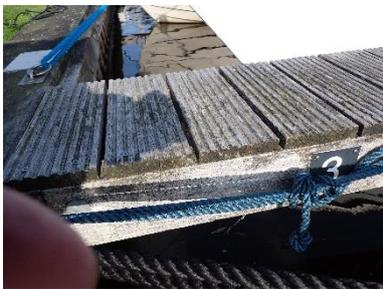
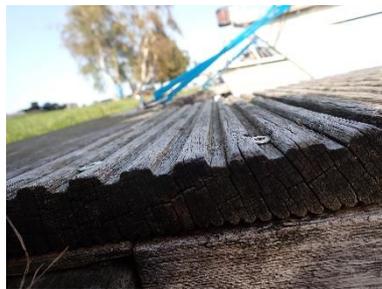
Landing stage 2 *Terminalia* species in both gang boards and horizontal construction, pole probably larch.

Condition good, sample taken from gangboard (S3).

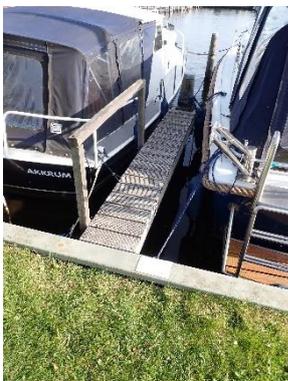
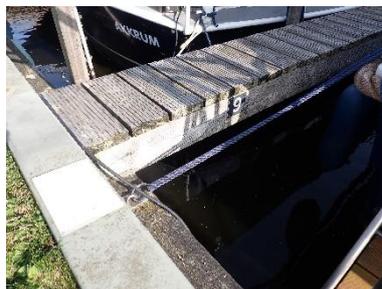
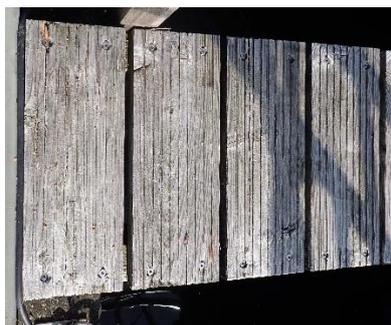
Landing stage 5 larch in all, gang boards, horizontal construction beams and pole. The gangboards are positioned with the heart side above, always. The gang boards and the horizontal construction beams are approaching their end of life stage, because of decay. In the gang boards the decay is mainly around the screws (especially at the 1st, 7th, 14th, 15th, 16th, 17th and 18th gang board). Because of the degradation, the screw connection is less tight and all boards can move somewhat compared to the horizontal beams. Also decay is found in the horizontal beams, where it is local and extending from the horizontal surface downwards. The condition of the pole is good above and below the water line, on the water line a 5 mm thick layer of weak decay is present only.

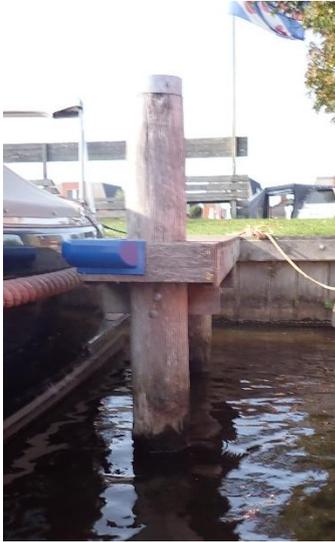
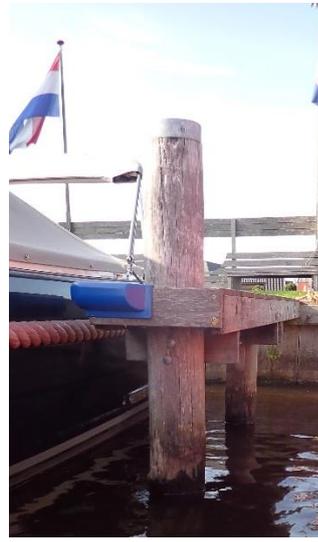
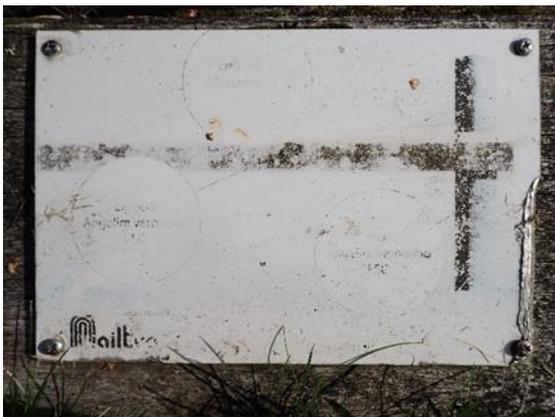
Landing stage 7 gangs boards are bamboo and two larch round poles.

The condition of the gang boards, horizontal beams and the poles are good. Sample is taken from the gang boards (S2).

Sign with landing stage seven turns out to be incorrect. The gang boards are made of bamboo and not of tanimbuca (= gindya udu), and the horizontal construction of angelim vermelho.

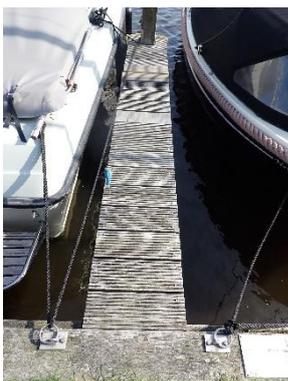
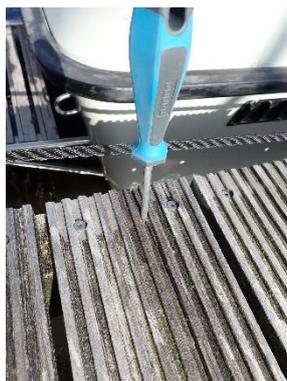
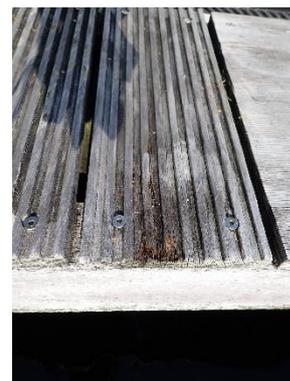
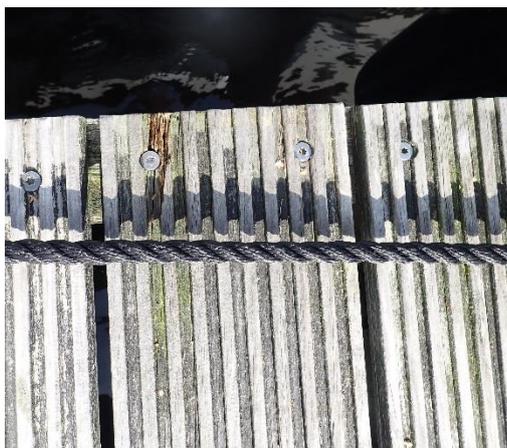
Landing stage 8 gangs boards are treated radiata pine. It is unclear if the horizontal construction beams are also treated radiata pine but the pole is larch.

The condition of the gang boards is not good, half of them are severely degraded from the cross surface onwards or already replaced, and in the other half there is some decay around the screws.

The condition of the pole and the horizontal beams are good.

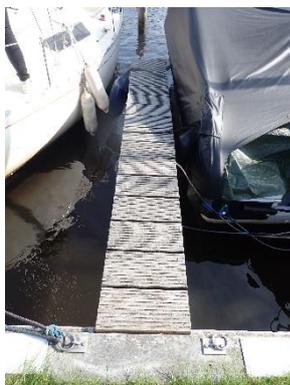
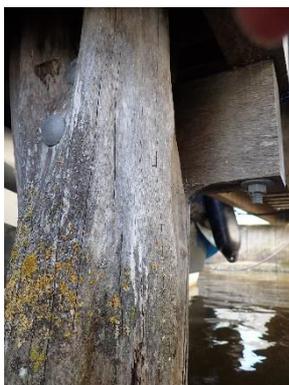
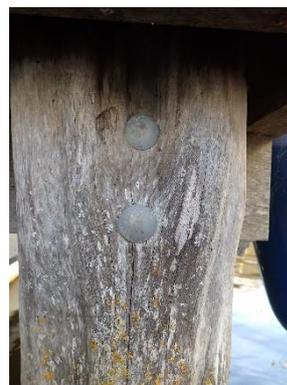
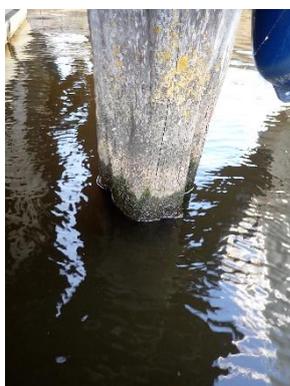
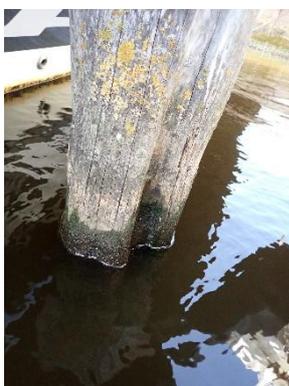
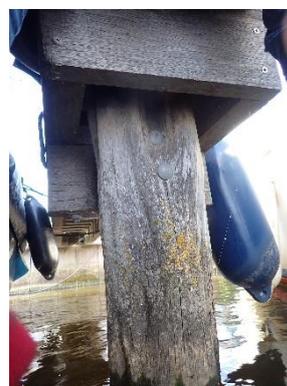
Landing stage 13 gangs boards of several species (manbarklak, angelim pedra, aldina, faveira amargosa), horizontal construction beams based on the goms flecks identified as angelim pedra, and the acariquara pole with the original tree trunk shape (non-machinable, e.g. non sawn). The condition of gang boards, horizontal construction beams and pole is good.

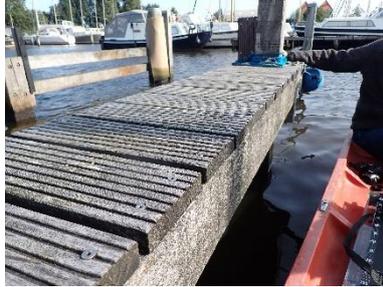
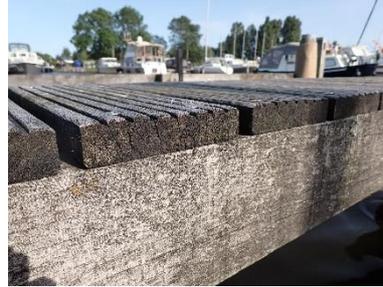
Landing stage 14 gang boards, horizontal construction beams and a sawn pole are all azobé. The condition of the gang boards, horizontal construction beams and pole is good.
