International Biodeterioration &amp; Biodegradation 61 (2008) 61–68

# Water flow through wooden foundation piles: A preliminary study

René K.W.M. Klaassen

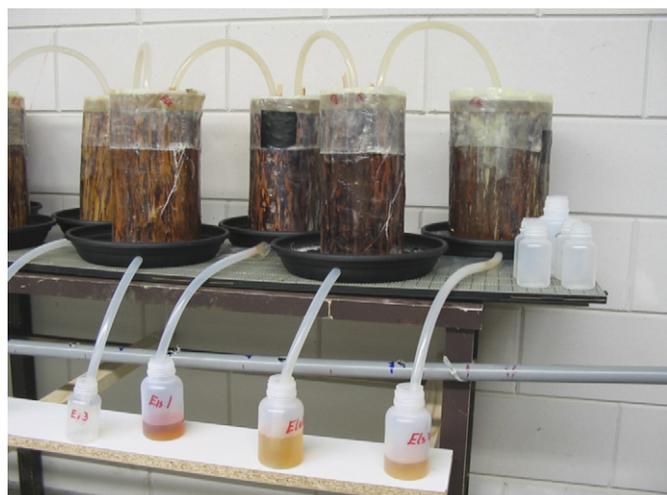
Fig. 1. Experimental design to study water flow through 300-mm-long stems without pressure.

At the upper end of the 300-mm-long stem segments, a collar of fibreglass was fixed and impregnated with epoxy resin (Fig. 1). In the collar, a constant layer of 10 mm water was kept to leave the cross sections permanently covered with water (without pressure). The stems were resting on plastic plates with a profile (rills) to enable the run-off of the penetrated water. In order to avoid evaporation from the plates, plastic foil was fixed around the stem and on the surface of the plate. A tube was connected to the lowest point of the plate to collect the water that penetrated through the stem. To avoid slime production by bacteria and algae, the water on the cross sections was refreshed weekly. After 4 weeks of continuous water flow through the stems the measurements were started. Throughout a period of 8 weeks, the amount of water that passed through the stems was recorded in weekly intervals.

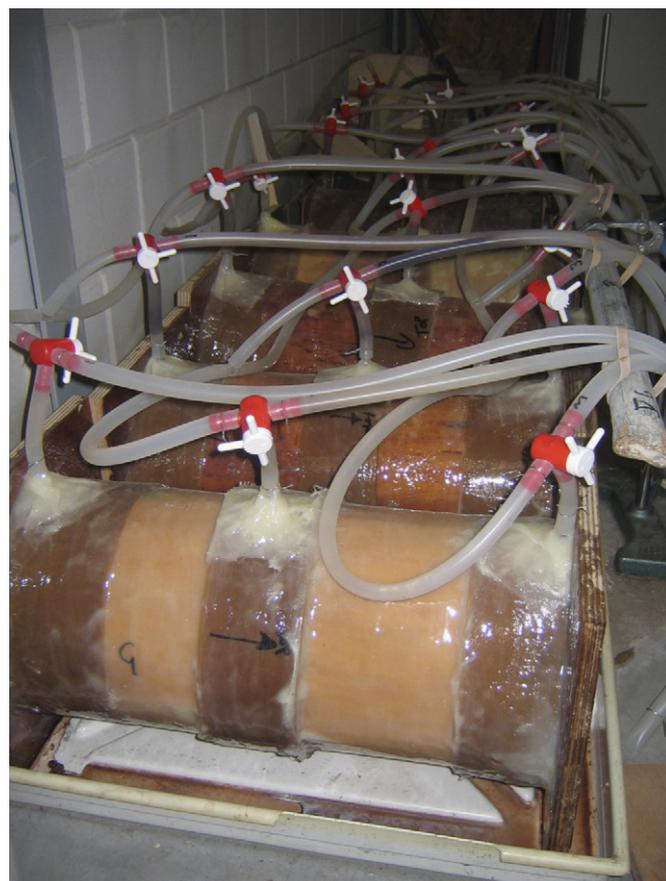
Fig. 2. Experimental design to study water flow through 450-mm-long stems under different pressures.

The 450-mm-long stems were placed horizontally (Fig. 2). At both cross sections, a fibreglass collar with a height of 30 mm and impregnated and fixed with epoxy resin was placed. Both collars were sealed with epoxy-impregnated plywood to form waterproof chambers.

In the middle of the 450-mm-long stems, a zone approximately 50 mm wide around the stem was left uncoated in order to also measure radial water transport. Here, a third chamber was created by wrapping a 10-mm-high collar made from fibreglass material at this location around the whole stem circumference (Fig. 2). To all three chambers, tubes of 300-cm length were connected. After removing all air from the three chambers, water with a pressure of 150 hPa, applied as a 150-cm water column, was put on one cross section. The tubes that were connected to the two remaining chambers were opened to release the water that penetrated the wood.

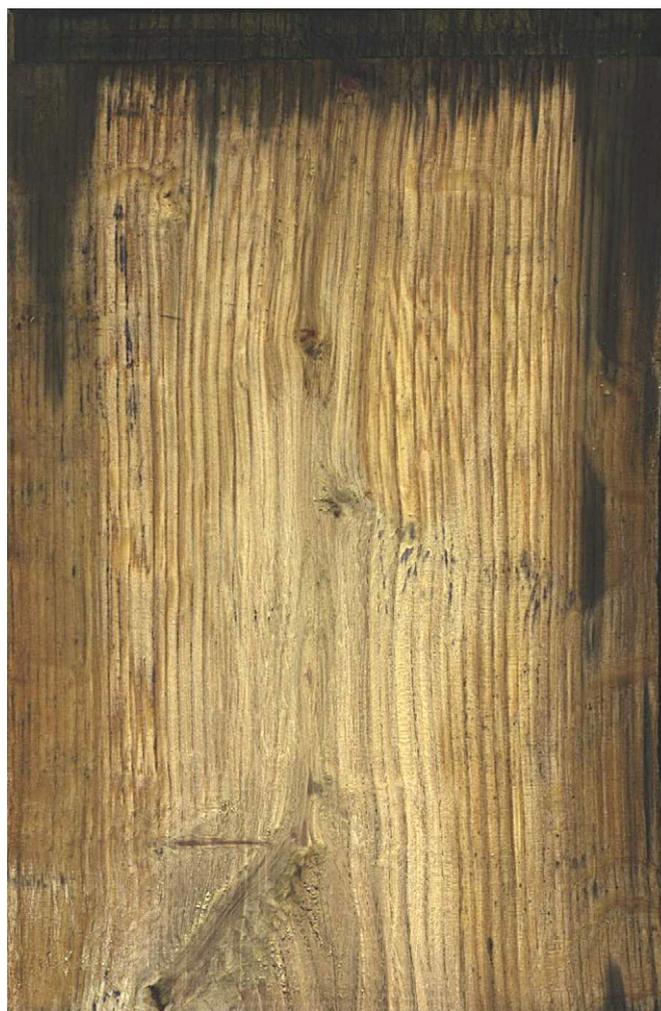
Fig. 4. Examples showing the stained water pathway in oak.

fir, and larch is almost completely impermeable due to irreversible closure of all bordered pits in the early-wood and the late-wood tracheids (Figs. 4–8). Alder, a species without heartwood, shows water flow throughout the whole stem (Fig. 5). In spruce, some pathways seem to remain open in the heartwood, which points to the presence of open pits, most likely in the latewood tracheids (Fig. 7).

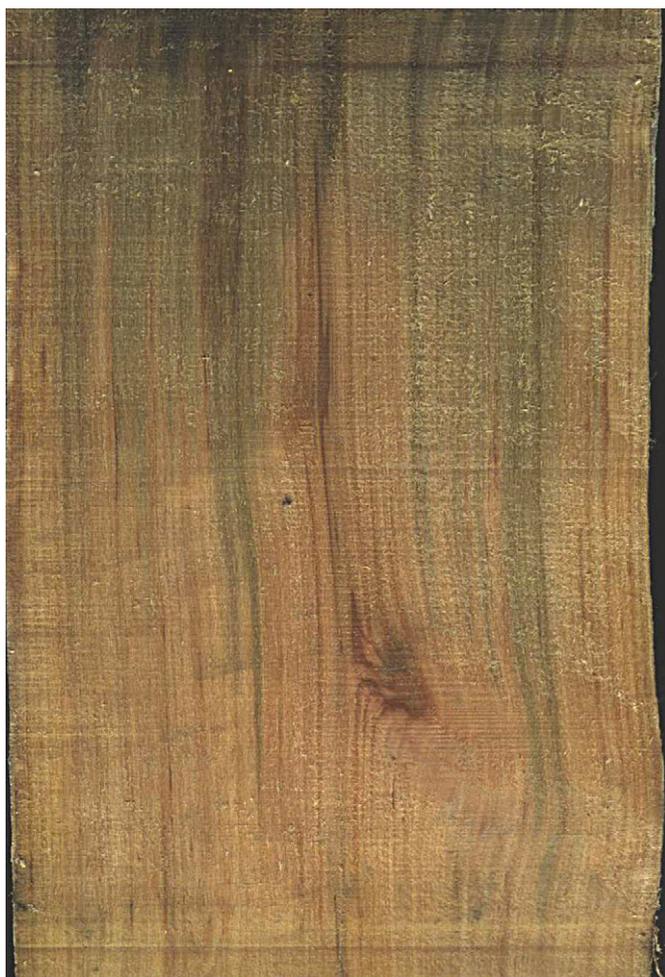
Fig. 5. Examples showing the stained water pathway in alder.

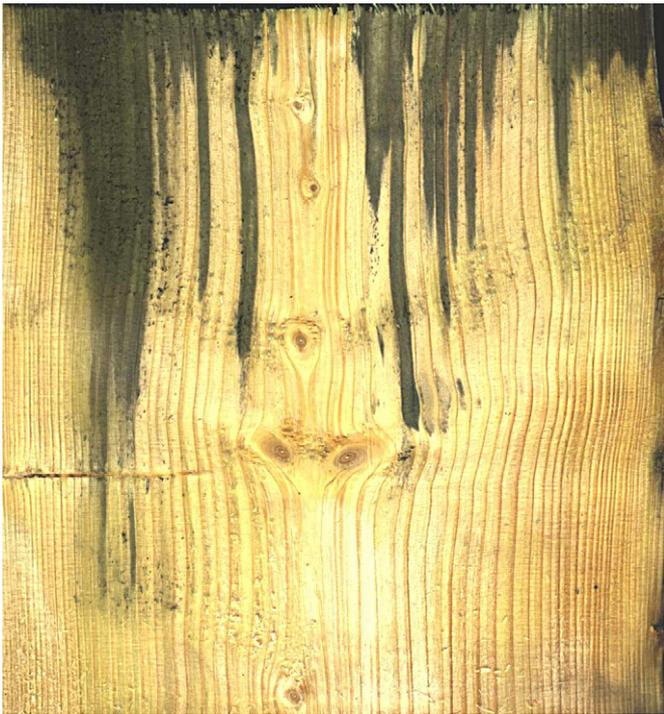
Fig. 7. Examples showing the stained water pathway in spruce.

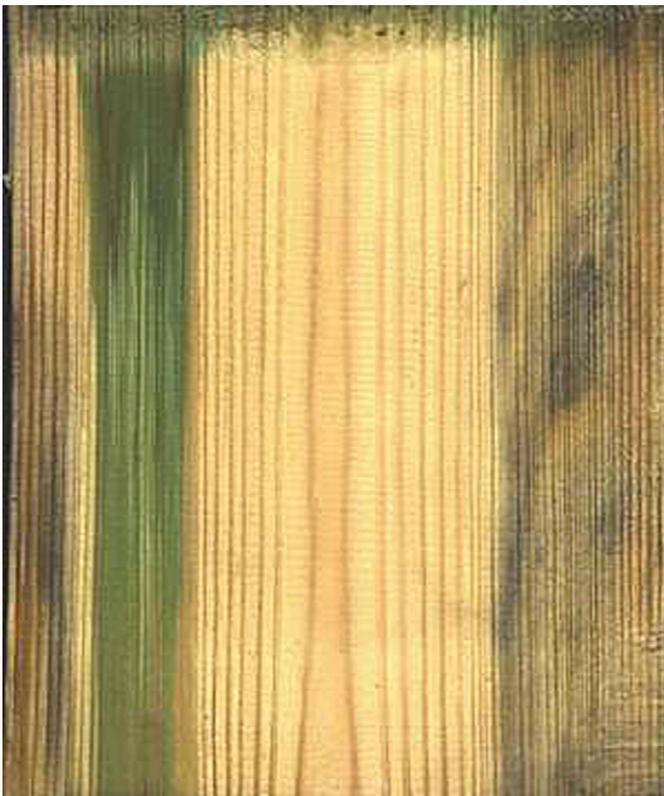
Fig. 8. Examples showing the stained water pathway in pine.

differences in water flow can possibly be explained by the presence of blue-stain fungi. The (commonly occurring) blue-stain infection could have induced partial—and in one heavily infected stem almost complete—obstruction of the water pathways. As this infection starts and most abundantly appears in ray (parenchyma) cells, it is possible that heavy infections with the consequence of intense production of fungal hyphae may lead to mechanical blockage of the low-resistant pathways, i.e., the wide window pits in pine. This interpretation is in conflict with the general idea that blue-stain infection generally enhances the permeability of wood by disintegrating pit membranes (e.g., Jutte, 1971). However, Fig. 8 supports the obstruction theory by showing that in sapwood areas with blue-stain infection (Fig. 8, left) no water flow is indicated.

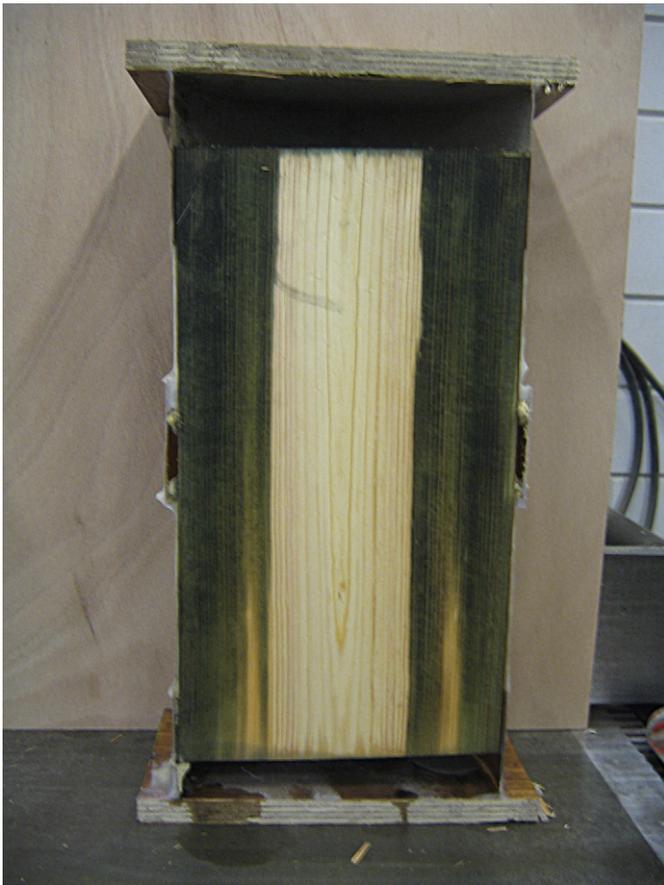
Fig. 11. Stained axial water pathway in pine.

In order to check whether (micro)cracks were involved in the case of high water flow, the water pathways of the pine and spruce stems with the highest water-flow intensity were stained. Figs. 11 and 12 clearly illustrate that water transport in both species occurred only through the wood.

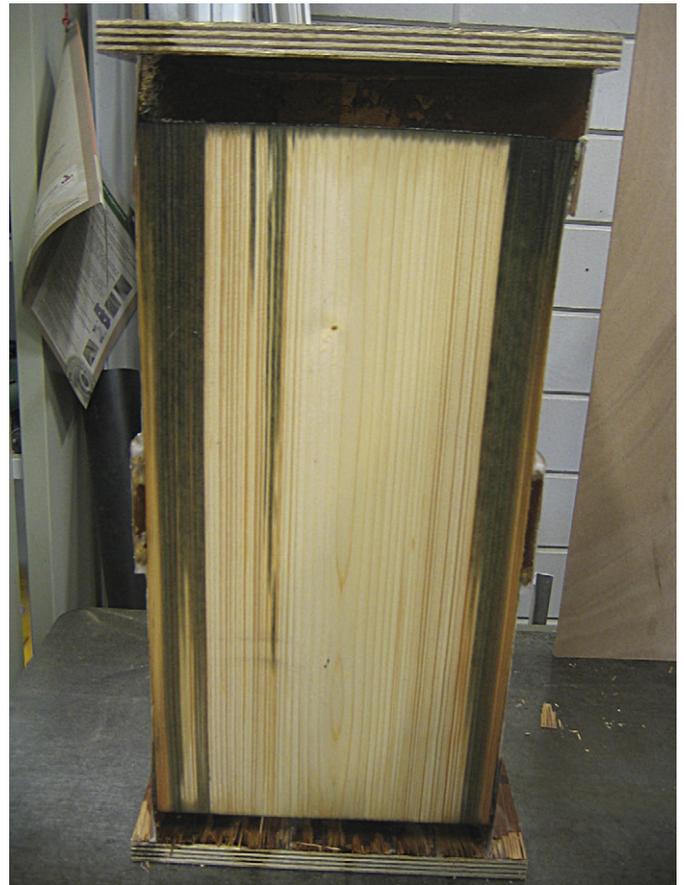
Fig. 12. Stained axial water pathway in spruce.
