Assessment report: State of the wooden construction, fresh water marina, Akkrum

Report code: 20.0382

Date: December 11th, 2020

Entries: Monitoring, timber species, landing stages, sheet pile, gang planks / boards, poles (hewn, sawn, round), purlins, stop logs poles, identification, decay.

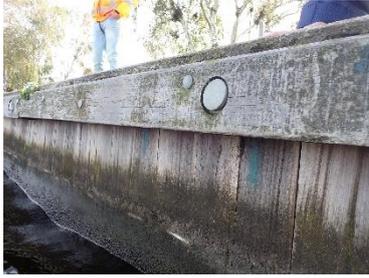
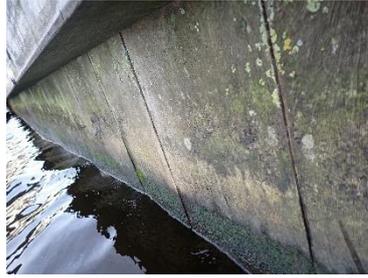
Sheet piles 1a, okan, start from the 25th sheet pile along the main river pathway (after the corner with the combination sheet piles, no. 3), thickness 40 mm, width 255 mm, 26th sheet width 155 mm, following sheets with variable width. Interlocked grain, fine wood structure, compared to all other sheet piles it is remarkable that there was almost no algae, mosses or plant growth; good condition (visually no decay and density profiles show weak decay only in outermost parts on top landside 15 mm, lower at waterside 10 mm). 27th sheet is sampled (M4) and density profiles were made.

Remarkable little attached growth of algae and mosses

knot

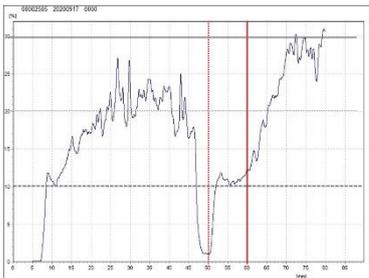
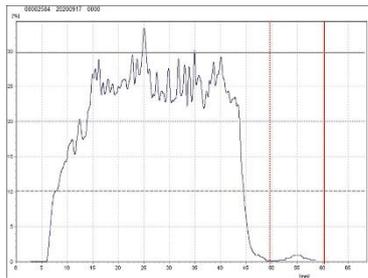
2505: no significant decay only weak decay landside 15 mm

2504: thickness 40 mm; no significant decay only weak decay waterside 10 mm

2503: no significant decay only weak decay waterside 10 mm

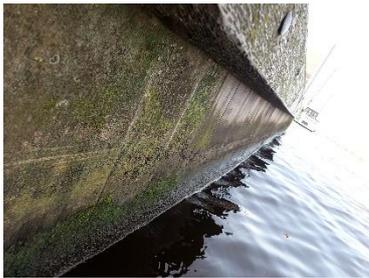
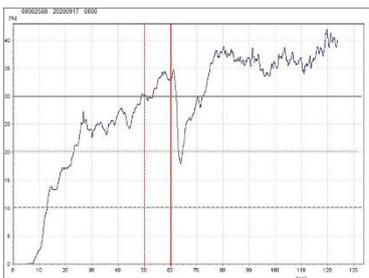
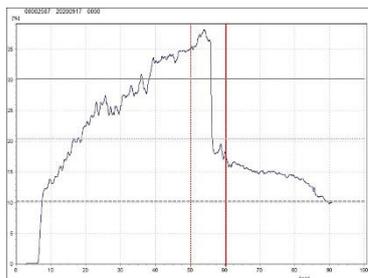
Sheet piles 1b, azobé, starts after sheet piles 1a and have variable widths of 240, 310, 320 and 340 mm. They have interlocked grain, fine wood structure, condition good (no visible decay, density profiles show only weak decay top 10 mm at landside, middle 10 mm at waterside and water level 5 mm in middle). 27th sheet is sampled (M5) and density profiles were made.

2508: no significant decay only weak decay landside 10 mm

2507 thickness app. 50 mm, no significant decay, only weak decay waterside 10 mm

2506: no significant decay, only weak decay behind a thin hard layer in 5 mm

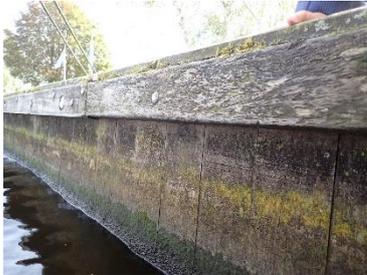
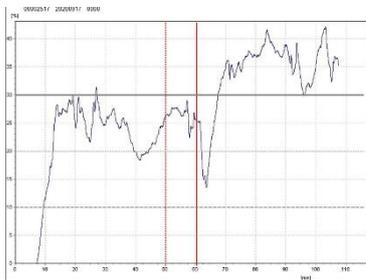
AB upper part (land side, approximately 15 cm from head)

Condition relative good (visible/ awl at top pile landside 5 mm decay, density profiles show only weak decay in the middle parts, most prominent in the upper 250 mm); the same sheet pile is sampled (M6) as from which the density profiles were made.

2517: no significant decay, only weak decay in middle 10 mm.

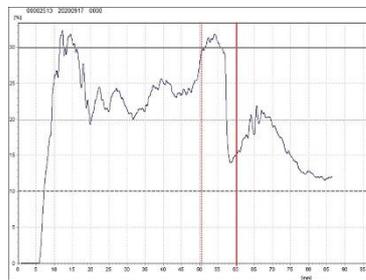
HV just below purlins (water side, 30 cm from head)

2513: thickness appr. 50 mm; no significant decay, only weak decay in middle 10 mm.

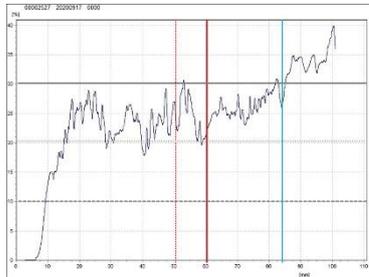
AB upper part (land side, approximately 15 cm from head)

Sheets piles 1d, tali, next after 1c sheet piles are located between pole 15 and 16. Thickness at least 40 mm. Condition relative good (visual no decay, density profiles moderate decay 10 mm deep waterside from 150 mm downwards, weak decay landside 5-15 mm top to water level, and middle top to 300 mm downwards 15 mm); the same sheet pile is sampled (M7) as from which the density profiles were made.

2527: no significant decay, only weak decay landside 5 mm and middle 15 mm

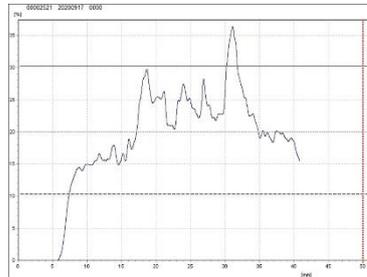
HV just below purlins (water side, 30 cm from head)

2521 thickness more than 40 mm; moderate decay waterside 10 mm, weak decay landside 15 mm and middle 15 mm

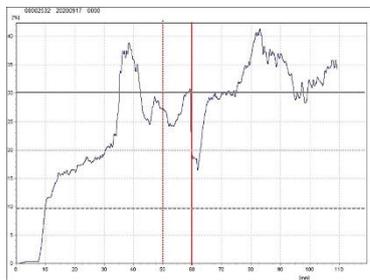
AB upper part (land side, approximately 15 cm from head)

Sheet piles 1e, okan, next few sheets piles after 1d sheet piles are located around pole 13. Thickness 50 mm. Condition relative good (visual, awl at top landside 1-2 mm decay, density profiles show weak decay in the middle and at the top landside 20 mm, and at the water level waterside 15 mm); the same sheet pile is sampled (M8) as from which the density profiles were made.

2532: weak decay landside 20 mm and middle 10 mm, rest no significant decay

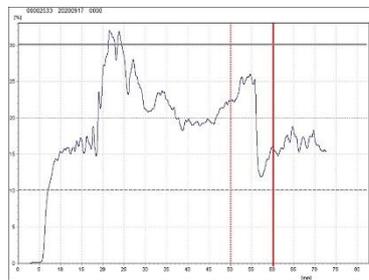
HV just below purlins (water side, 30 cm from head)

2533 thickness app. 50 mm; weak decay waterside 15 mm and middle 20 mm, rest no significant decay

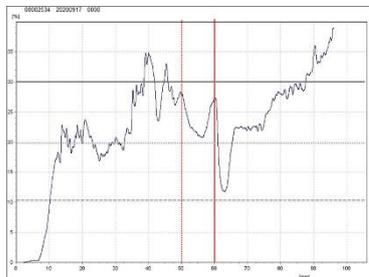
Sheet piles 1f, tali, next few sheets piles after 1e sheet piles are located around pole 9. Thickness 50 mm. Condition is good (density profiles show weak decay at waterside over whole length in 5 mm, and at the top in the middle 5 mm). The same sheet pile is sampled (M9) as from which the density profiles were made.

2534: no significant decay, only weak decay landside 5 mm, middle 5 mm (behind hard peal waterside)
AB upper part (land side, approximately 15 cm from head)

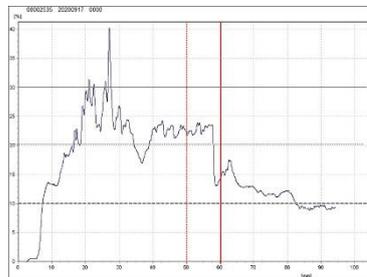
2535 thickness app. 50 mm, no significant decay, only weak decay waterside 5 mm
HV just below purlins (water side, 30 cm from head)

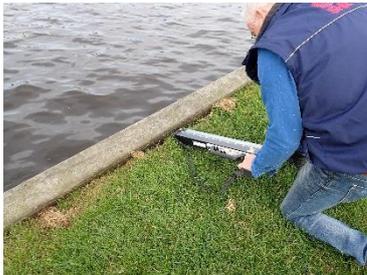
Sheet piles 1g azobé, next few sheets after 1f sheet piles are located around pole 7. Thickness 50 mm. condition questionable (visual / awl top landside white rot 30 mm deep, density profiles show moderate decay in the upper 300 mm at the landside 10-20 mm and in the middle part 15-25 mm, at the water level the decay is less weak); the same sheet pile is sampled (M10) as from which the density profiles were made.

Skewed drilling

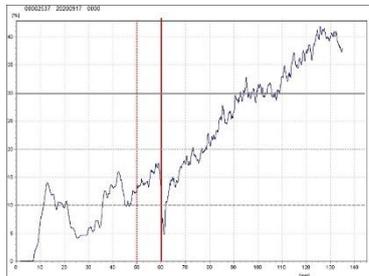
upper part (land side, approximately 15 cm from head)

2537: moderate decay landside 10 mm, middle 25 mm, weak decay waterside 15 mm

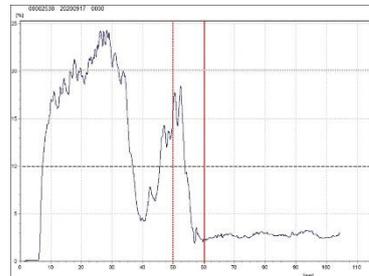
just below purlins (water side, 30 cm from head)

2538 thickness app. 50 mm, decay moderate landside 20 mm, moderate -severe middle 15 mm, rest (waterside) no significant decay 25 mm

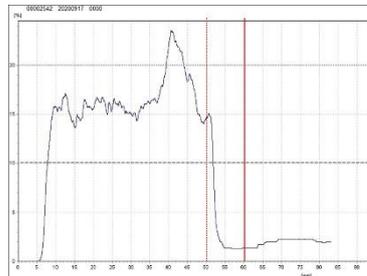
just below purlins (water side, 30 cm from head)

2542 thickness app. 50 mm, no significant decay

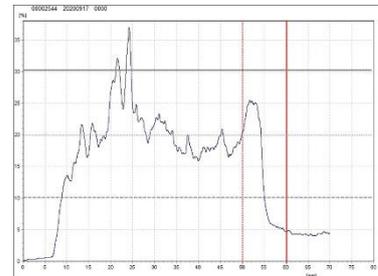
just above water level (water side)

2544: weak decay waterside 10 mm, middle 20 mm, rest no significant decay

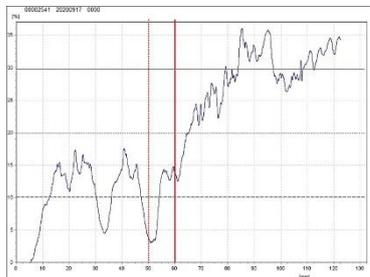
upper part (land side, approximately 15 cm from head)

Thickness 50 mm. Condition bad (visual / awl top landside deeply degraded, density profiles show moderate to severe decay in large parts of the pile); the same sheet pile is sampled (M12) as from which the density profiles were made, is the first pile of this species.

2541: decay moderate to severe over whole thickness.

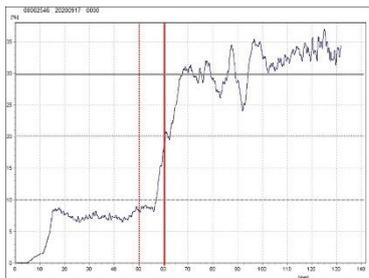
2546: decay moderate to severe over whole thickness.

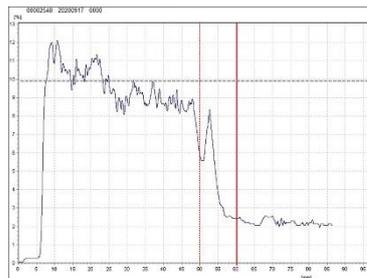
2548: decay moderate to severe over whole thickness

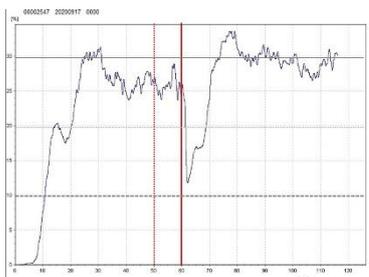
upper part (land side, approximately 15 cm from head)

2547: no significant decay, only weak decay landside 10 mm

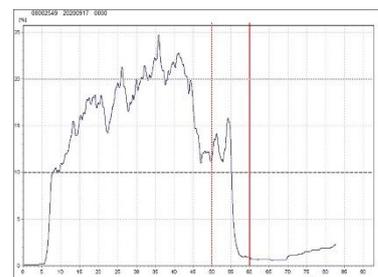
just above water level (water side)

2549: moderate decay landside 10 mm, weak decay waterside 15 mm, rest no significant decay

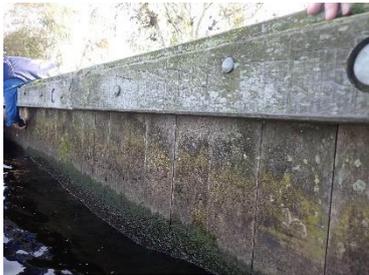
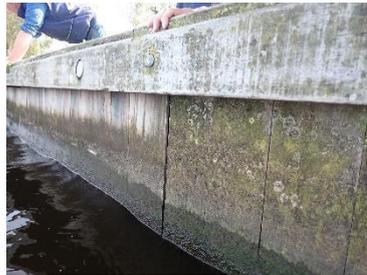
Sheet piles 2, angelim vermelho, the first 24 sheets piles along the main river pathway after the corner with the combination sheet piles 3. It is assumed that the lower parts of the sheet piles is Austrian larch, thickness 45 mm, width approximately 180 mm, rabbet 20 x 20 mm. The condition of the piles is good (no visible or with density profiles detectable decay), third sheet is sampled (M3) and density profiles were made.

Transition of the angelim vermelho -larch sheet piling to sheet pile 1a okan

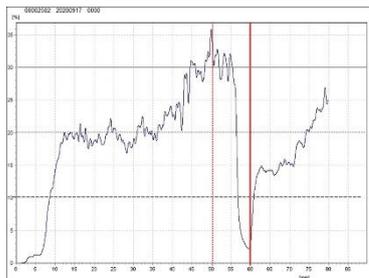
AB upper part (land side, approximately 15 cm from head)

2502: no significant decay both water and landside

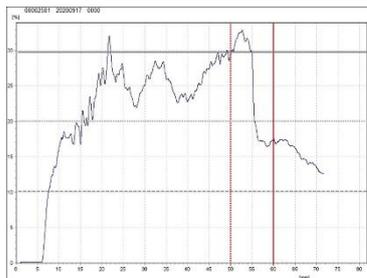
HV just below purlins (water side, 30 cm from head)

2501: thickness is app 45 mm, no significant decay both water and landside

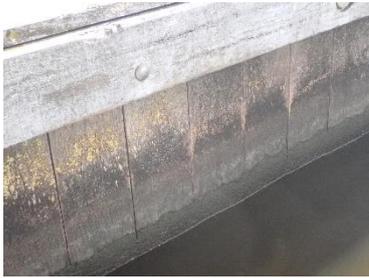
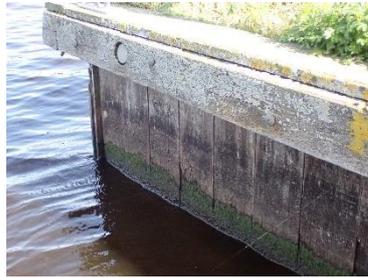
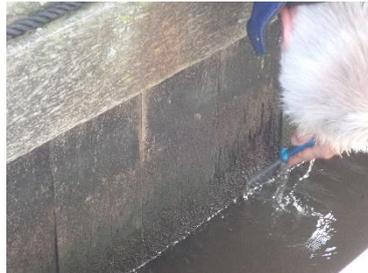
Sheet pile 3, combination sheet pile (Van Swaay), situated over the full short end of the island. The upper part is angelim vermelho, thickness 45 mm, width approximately 180 mm, rabbet depth 20 mm, 22 mm wide and the lower part is probably a softwood. Most upper parts are sound, no decay, a few upper parts show some bugling and occasionally some plant growth through the nails.. The condition of the eighth sheet from the corner with the frontside of the island, was questionable (visually degraded, density profiles show weak to moderate decay on waterside at middle) (M1, lost its smell), adjacent sheet was good (visually no decay, density profiles show weak decay in top 15 mm on landside, 10 mm middle), (M2). Both samples confirm the wood species.

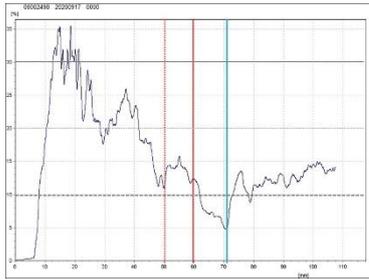
2498: landside no significant decay, weak decay middle 25 mm, moderate decay waterside 10 mm

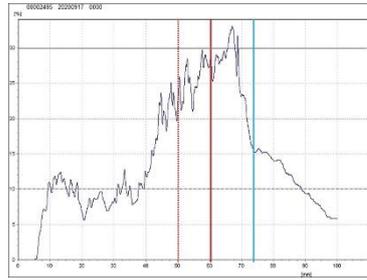
2495: no reliable thickness estimation here because of skewed measurement; landside no significant decay, weak decay middle 10 mm, moderate decay waterside 25 mm

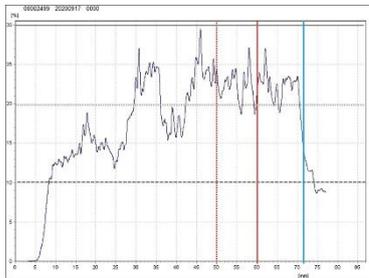
upper part (land side, approximately 15 cm from head),

2499: landside weak decay in 15 mm, 10 mm in middle, rest no significant decay

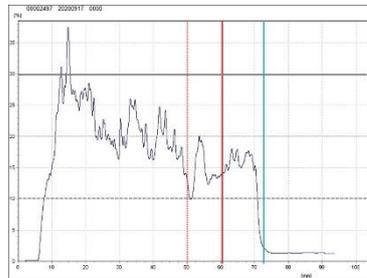
just below purlins (water side, 30 cm from head)

2497: no reliable thickness estimation here because of skewed measurement; weak decay in middle 10 mm, rest no significant decay

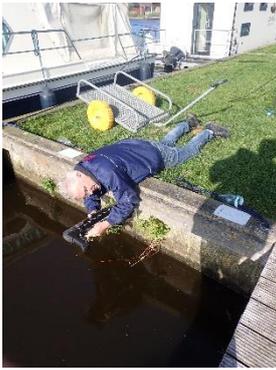
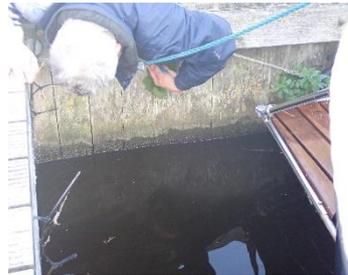
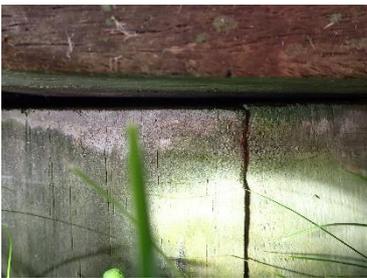
Approximately 39 combination sheet piles with Accoya, thickness 53 mm, width 132 mm, moisture content (at density 0,65 g/cm³) both land and water side 20-35%, no detectible decay, finger joints to the supposed lower spruce part were not detected (between cross surface Accoya and decking at least 5 mm space, some plant grow between the beams).

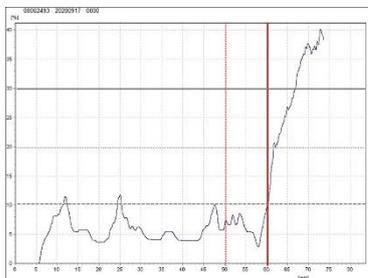
upper part (land side, approximately 15 cm from head),

2493: no significant decay both water and landside

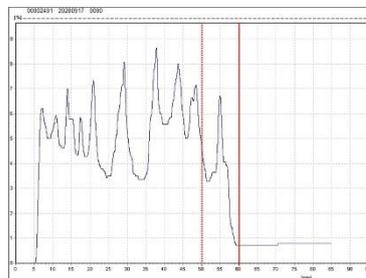
just below purlins (water side, 30 cm from head)

2491: no reliable thickness estimation here because of skewed measurement; no significant decay both water and landside

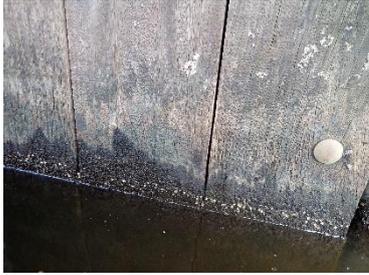
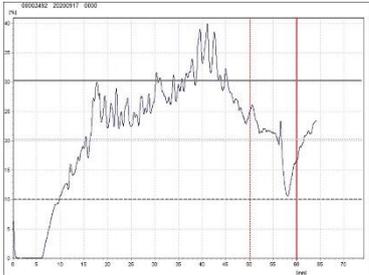
upper part (land side, approximately 15 cm from head)

2492: landside weak decay in 10 mm, rest no significant decay

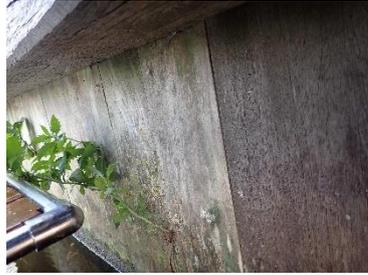
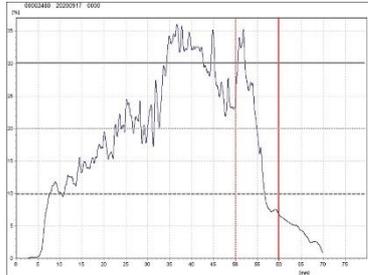
just below purlins (water side, 30 cm from head)

2488: waterside weak decay in 15 mm, 5 mm in middle, rest no significant decay

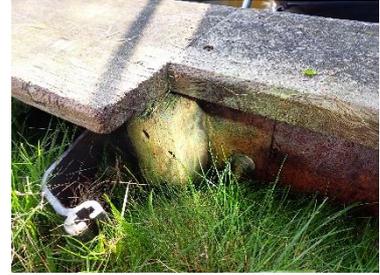
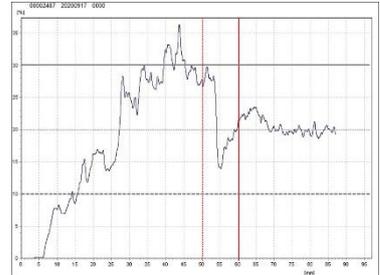
just above water level (water side)

2487: waterside weak decay in 20 mm, 2 mm in middle, rest no significant decay

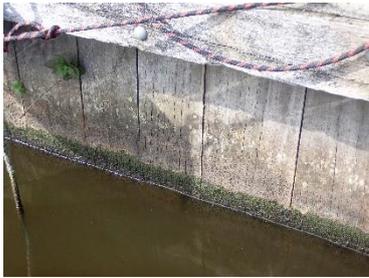
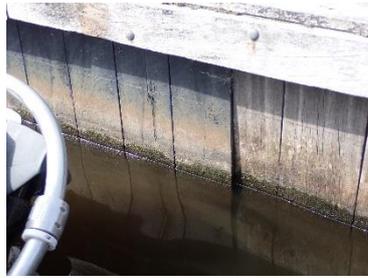
Sheet piles 9, reused azobé sheet piles. Thickness 50 mm. Condition good (visual / awl top landside superficial decay, density profiles no significant decay, only weak decay at top both land-and waterside in 5 mm, and on the water level waterside 10 mm and middle 20 mm); the same sheet pile is sampled (M16) as from which the density profiles were made, is the last pile of this species. Cover plank severely degraded with many ants.

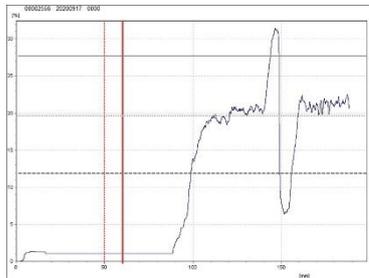
upper part (land side, approximately 15 cm from head),

2556: no significant decay, besides weak decay landside behind hard peal 5 mm, waterside 5 mm.

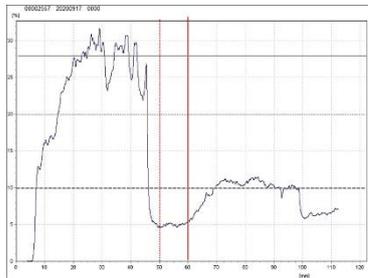
just below purlins (water side, 30 cm from head)

2557 thickness app. 50 mm, no significant decay

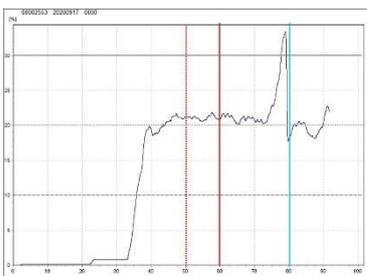
2553: weak decay over the full thickness, hard peal waterside.

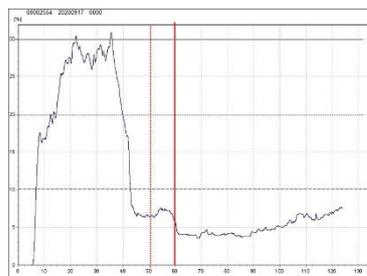
2554 thickness app. 40 mm, no significant decay, only weak decay land- and waterside 5 mm, HV just below purlins (water side, 30 cm from head)

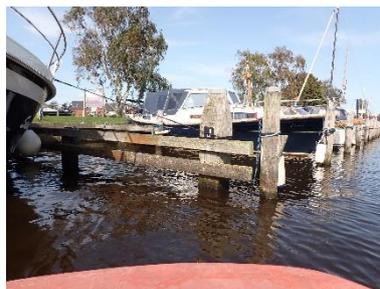
Fifth pole (MP2)

Round hardwood pole, no significant decay on and above the water line. Diameter poles approximately 22 cm. The density profile taken approximately 20 cm above the water line, shows a degraded outer most sheet of 20-30 mm. Wood sample (MP2) was taken.

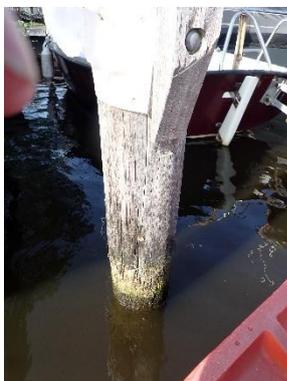
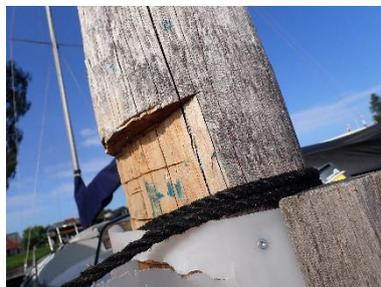
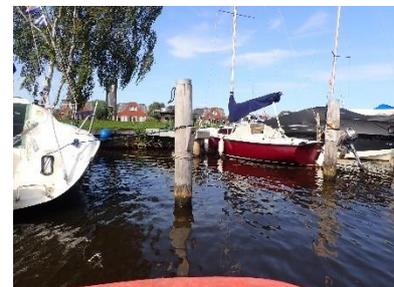
Left picture: 6th pole from the corner

No remarks, from the 6th pole a slice of wood was removed above the water level. From the 11th pole above the water level wood sample MP5 was taken.

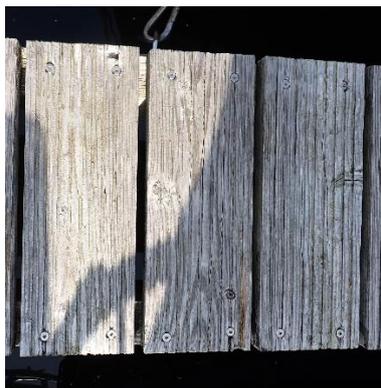
Board 1-4

Landing stage 5 larch in all, gang boards, horizontal construction beams and pole. The gangboards are positioned with the heart side above, always. The gang boards and the horizontal construction beams are approaching their end of life stage, because of decay. In the gang boards the decay is mainly around the screws (especially at the 1st, 7th, 14th, 15th, 16th, 17th and 18th gang board). Because of the degradation, the screw connection is less tight and all boards can move somewhat compared to the horizontal beams. Also decay is found in the horizontal beams, where it is local and extending from the horizontal surface downwards. The condition of the pole is good above and below the water line, on the water line a 5 mm thick layer of weak decay is present only.

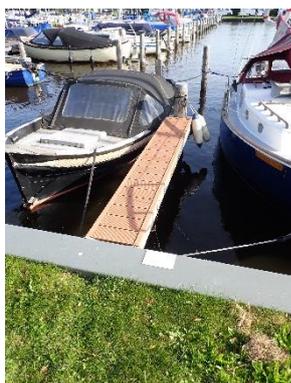
Landing stage 7 gangs boards are bamboo and two larch round poles.

The condition of the gang boards, horizontal beams and the poles are good. Sample is taken from the gang boards (S2).
